Important Information for Homeowners!

The Urbandale Building and Fire Departments would like to provide important information to Urbandale residents who have Corrugated Stainless Steel Tubing (CSST) gas pipe in their home.

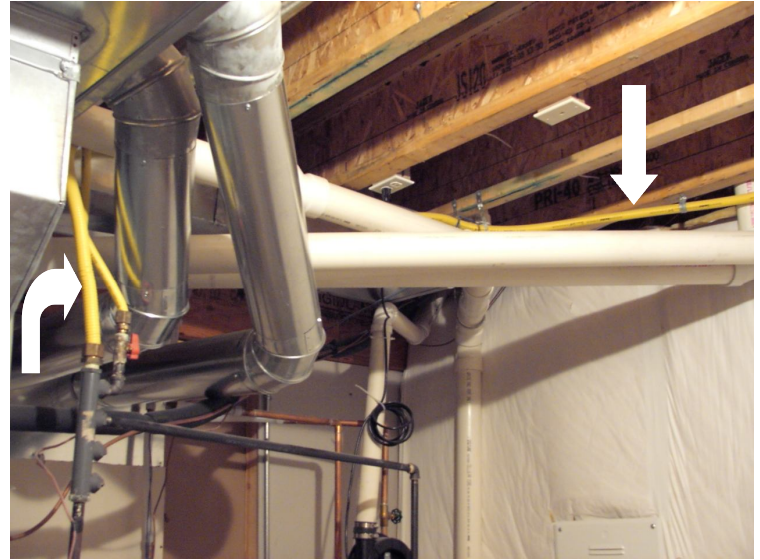
CSST pipe is a flexible, metal gas piping system used in many homes constructed or remodeled since the early 1990s. The corrugated tubing can be identified by a yellow plastic coating. The picture to the right shows what yellow CSST looks like. You commonly will see it where your water heater, furnace, or fireplace are located.

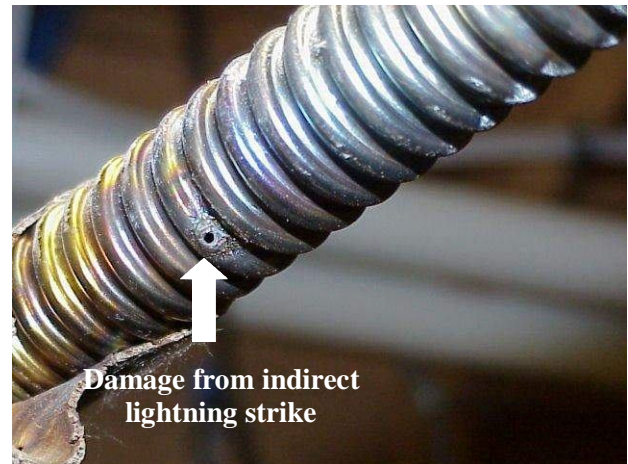
Many installations of CSST prior to 2010 do not have the appropriate bonding needed for the tubing. Proper bonding may reduce the risk of damage or fire from a lightning strike. Even a nearby lightning strike that does not strike a structure directly can cause damage to CSST tubing that is not properly bonded.

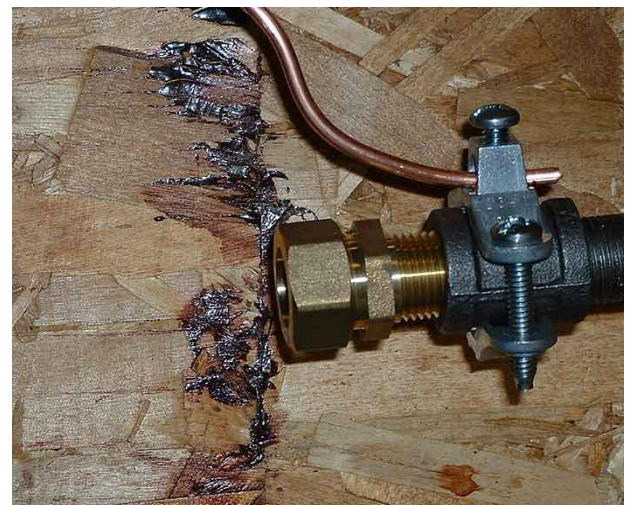
If you do not see any metal clamps or copper wire where your gas line enters your home from the outside or on any black iron pipe near CSST in your utility room, you are encouraged to contact an electrician or your home builder to assist you in determining the appropriate bonding that may be needed for the CSST in your home.
